# Manhole Inspection Summary

Manhole # S150\_\_030MH

Insp Date: **4/7/08 10:08 AM**

**Location** Address: **2661 dulany-lehman alley**

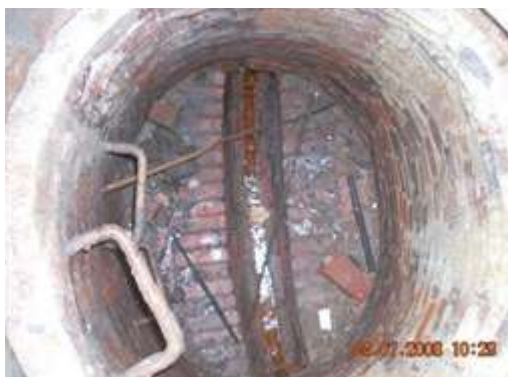
misc

bench debris

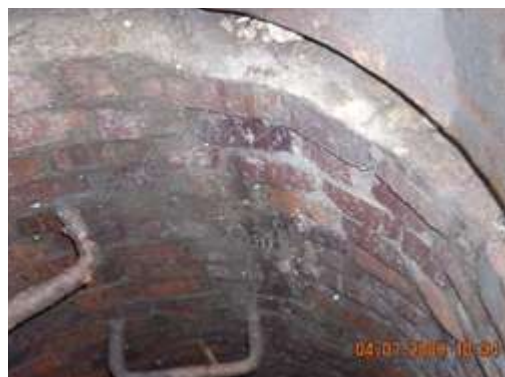
Defect 5

infiltration @ chimney joint

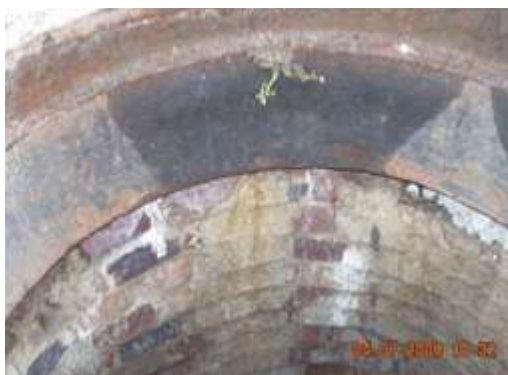
Defect 4

inflow evidence

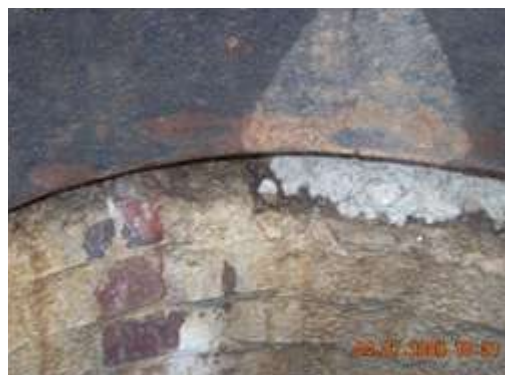
Defect 3

☒ **Deteriorated**

deteriorated chimney

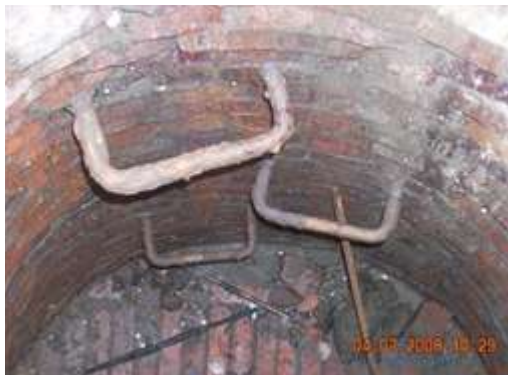
Defect 2

☒ **Corroded**

corroded steps

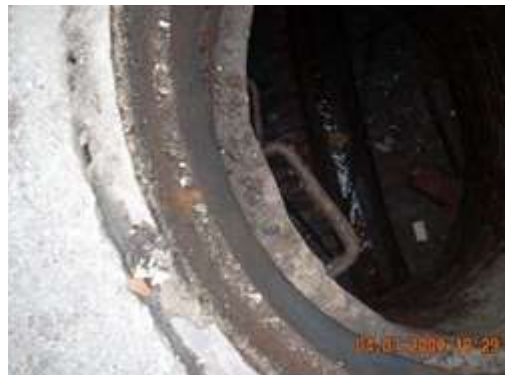
Defect 1

Offset: **1** (in.)

frame offset

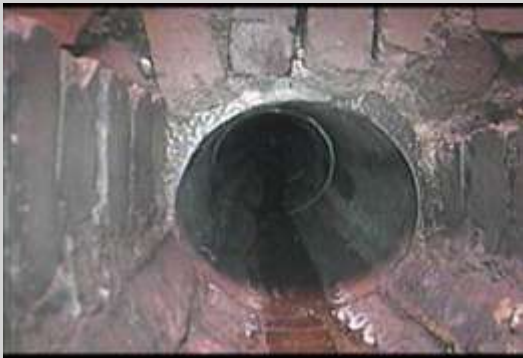
12 O'Clock Outflow

Pipe Height: **8.4** (in.) Rod and Bar (Angled)  
Pipe Material: **Clay** ☐ Pipe Lined  
Invert Depth: **7.01** (ft.) Flow Characteristics: **Slow**  
Deposits: ☒ None ☐ Mud ☐ Sludge ☐ Debris ☐ Grease  
Silt Depth: **0** (in.) Deposits Extent:  
Infiltration: **None** Pipe Seal Cond: **Cracked**
